ENERGY EFFICIENT ENGINE

PIN FIN AND CERAMIC COMPOSITE SEGMENTED LINER

COMBUSTOR SECTOR RIG TEST REPORT

UNITED TECHNOLOGIES CORPORATION
Pratt & Whitney
Engineering Division

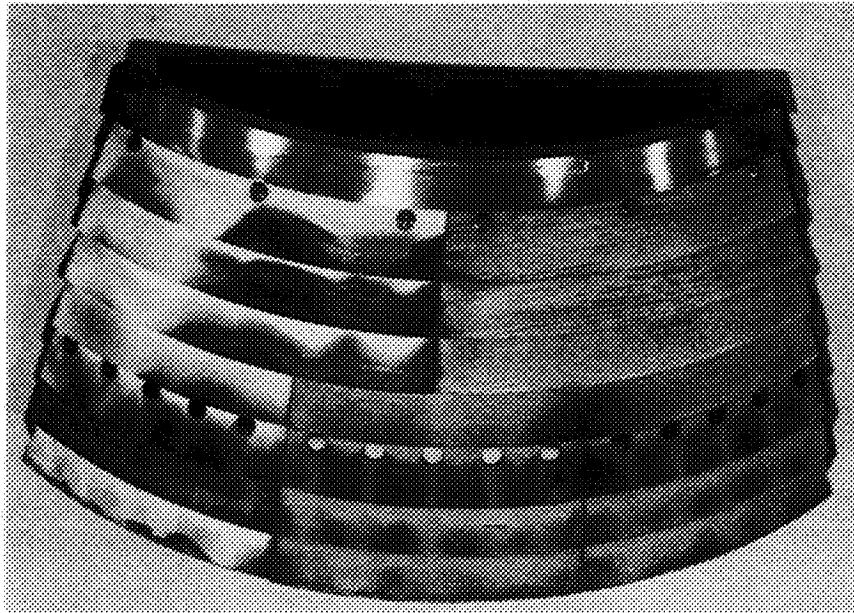
Figure 4-10 Hot Side of Ceramic Combustor Inner Liner After Completion of Run 26 Durability Test

After removing the rig from the test stand, it was disassembled for post-test examination and inspection. Initial examination indicated no substantial large-scale damage or distress to the composite liner panels. Figure 4-10 shows the inner liner assembly prior to the panels being removed from the metal shell. (The light colored regions on the panels on the left side of the liner are thermal paint.) In Section 5.3.2, the results of detailed inspections of the panels are discussed.

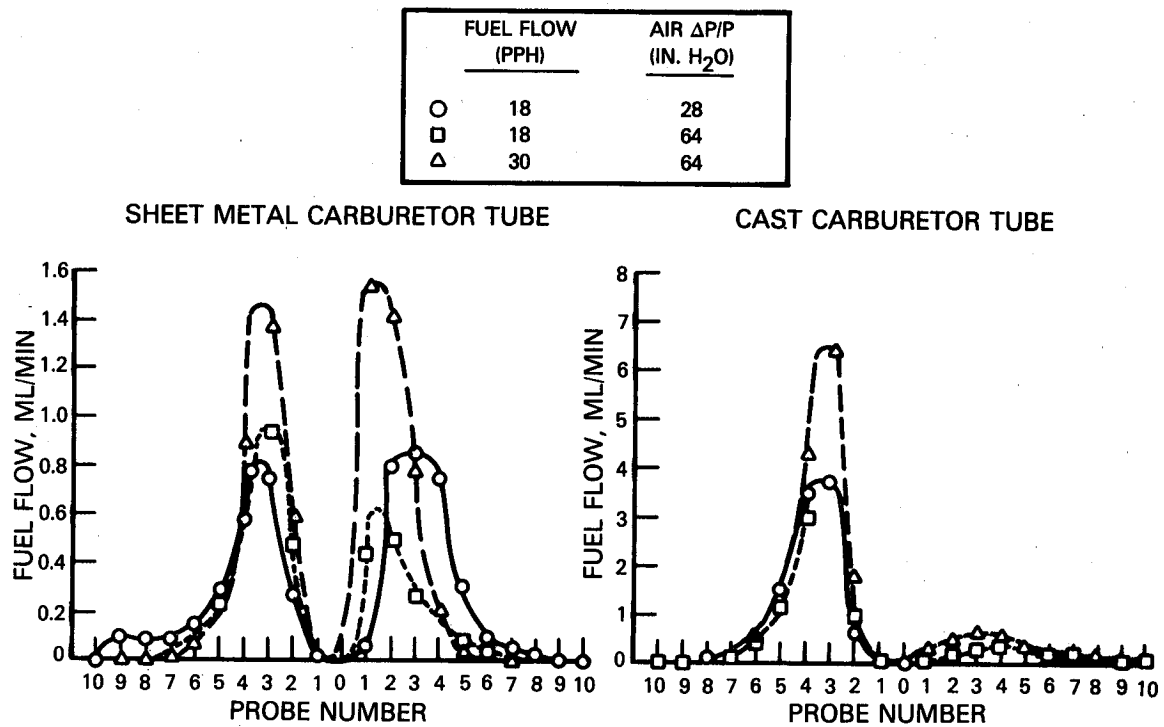
Figure 5-2 Comparison of Carburetor Tube Fuel Spray Characterization

- Run 21 - Final sheet metal carburetor tubes geometry evolving from initial Combustor Sector Test Program
- Run 22 - Adaptation of the full annular component carburetor tubes made by investment casting
- Run 23 - Modification made to the outer sleeve casting to alleviate problems from Annular Rig Program and Run 22.

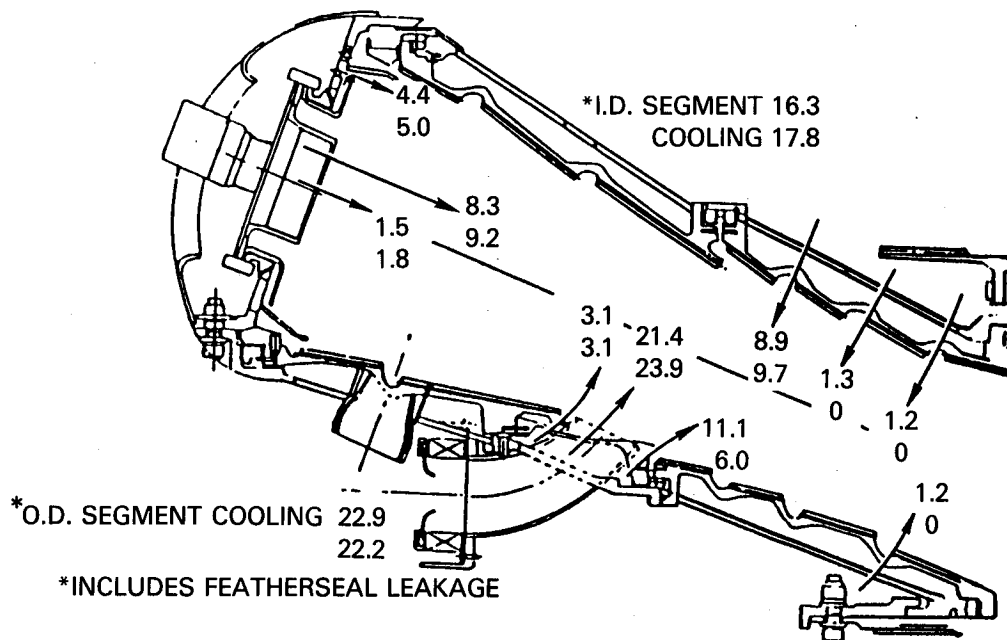
TOP NUMBERS SHOWN REPRESENT SECTOR RIG (BUILD 22) VALUES
 BOTTOM NUMBERS SHOWN REPRESENT SECTOR RIG (BUILD 23) VALUES

Figure 5-3 Combustor Airflow Distribution

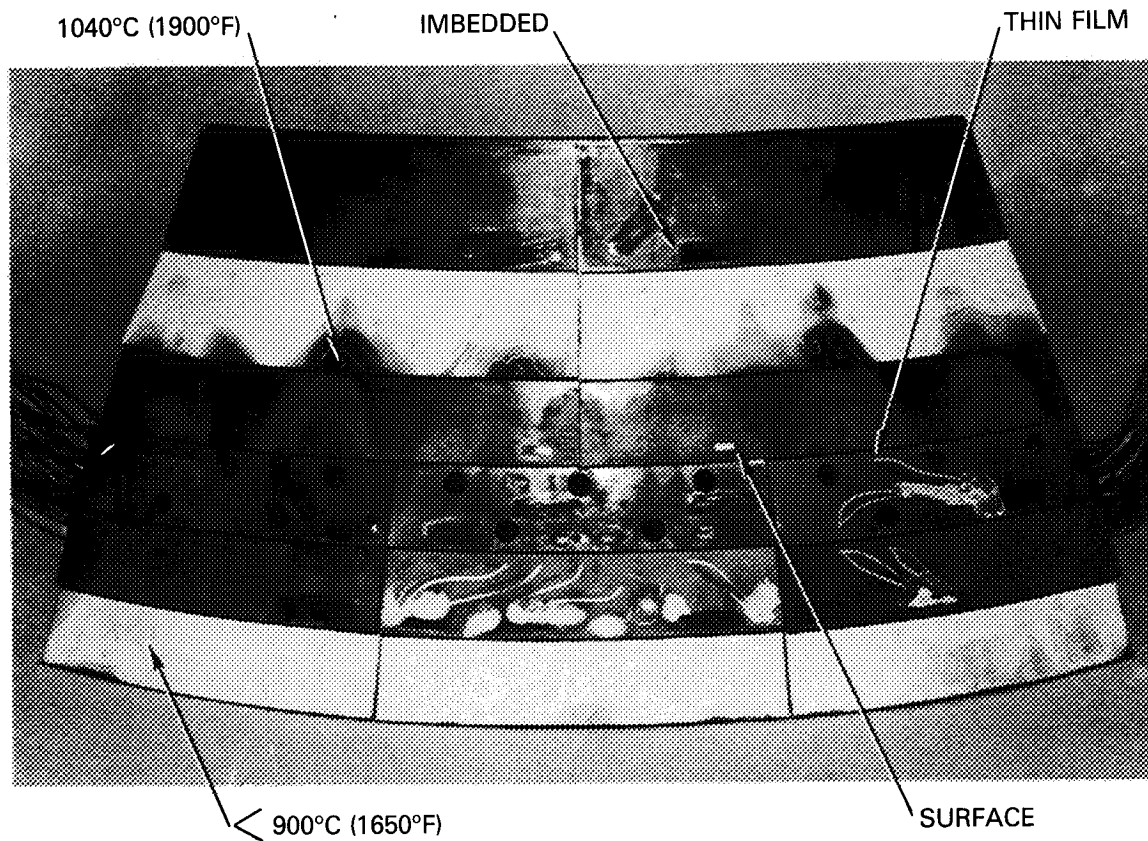
Figure 5-11 Pin-Fin Inner Liner After Run 24. Peak Condition: $T_{T3} = 566^{\circ}\text{C}$ (1050°F); $P_{T3} = 2.8 \text{ MPa}$ (400 psia); $T_{T4} = 1466^{\circ}\text{C}$ (2670°F)

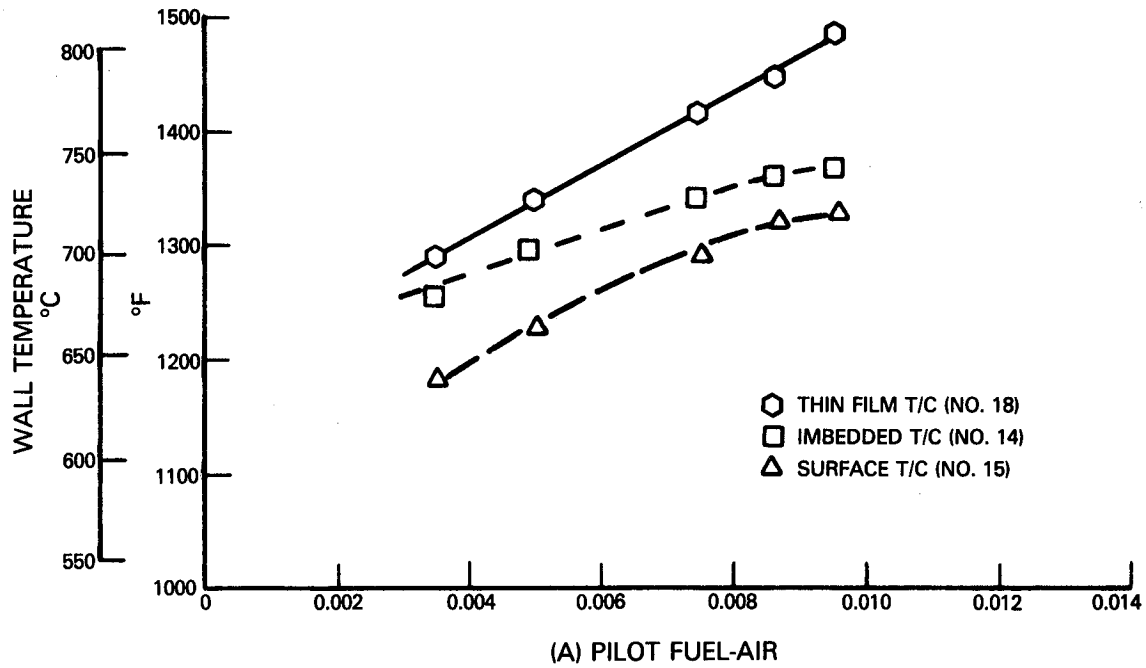
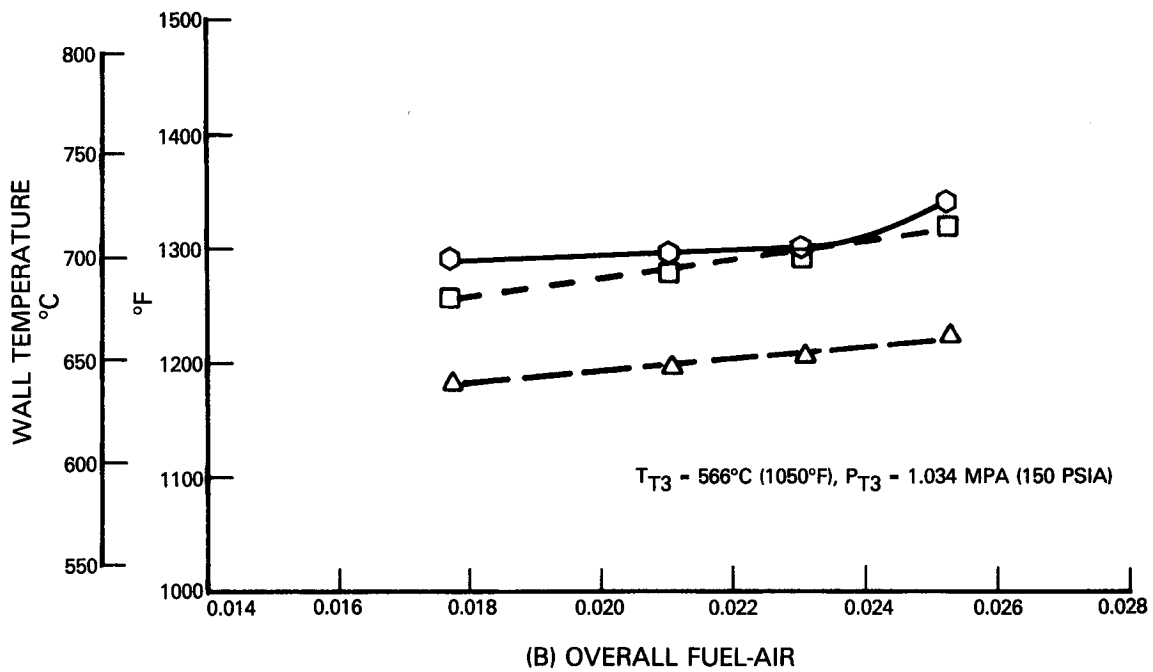
Figure 5-12 Comparison of Thermocouple Types Installed In Similar Locations

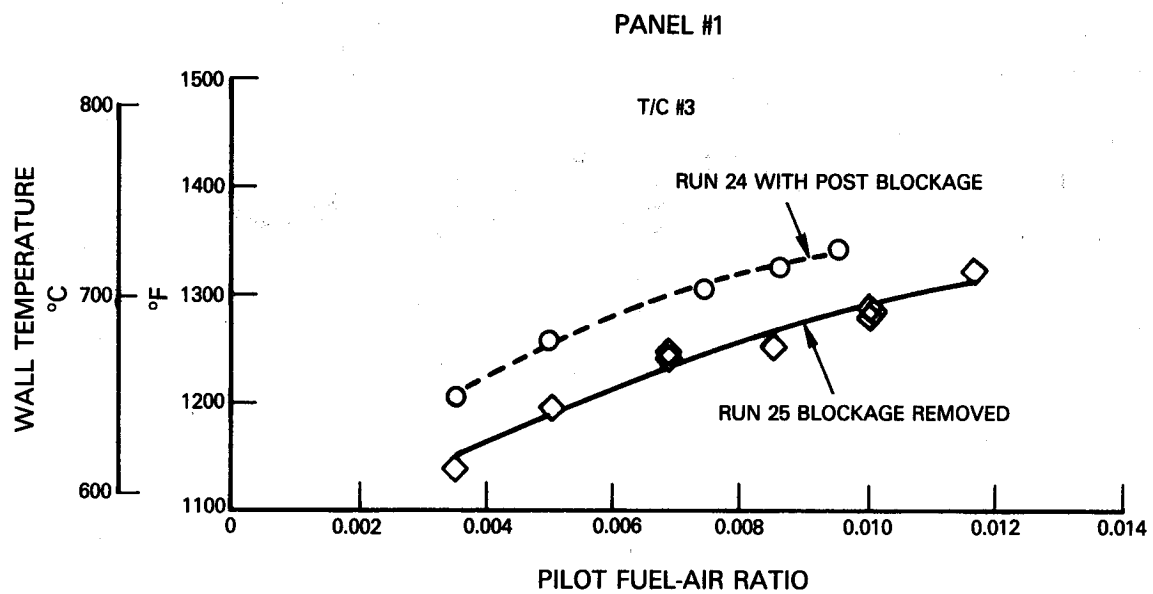
Figure 5-27 Effect of Removing Casting Blockage on Panel #1 Wall Temperature

The impact of thinning out the blockage around the mount post pads is evident in Figure 5-27. The thermocouple (No. 3) is installed on the hot surface in very close proximity to the modification. Wall temperature reduction of approximately 30°C (50°F) was achieved.

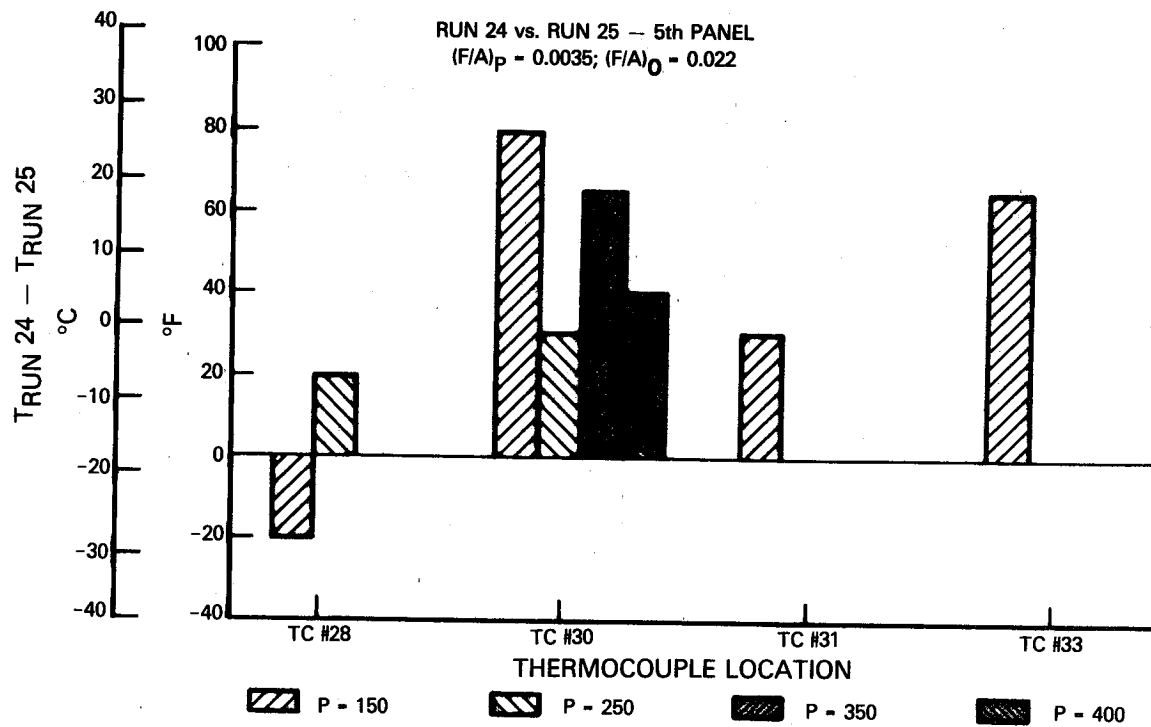
Figure 5-28 Comparison of Dense (Run 25) vs Sparse (Run 24) Pin-Fin Array

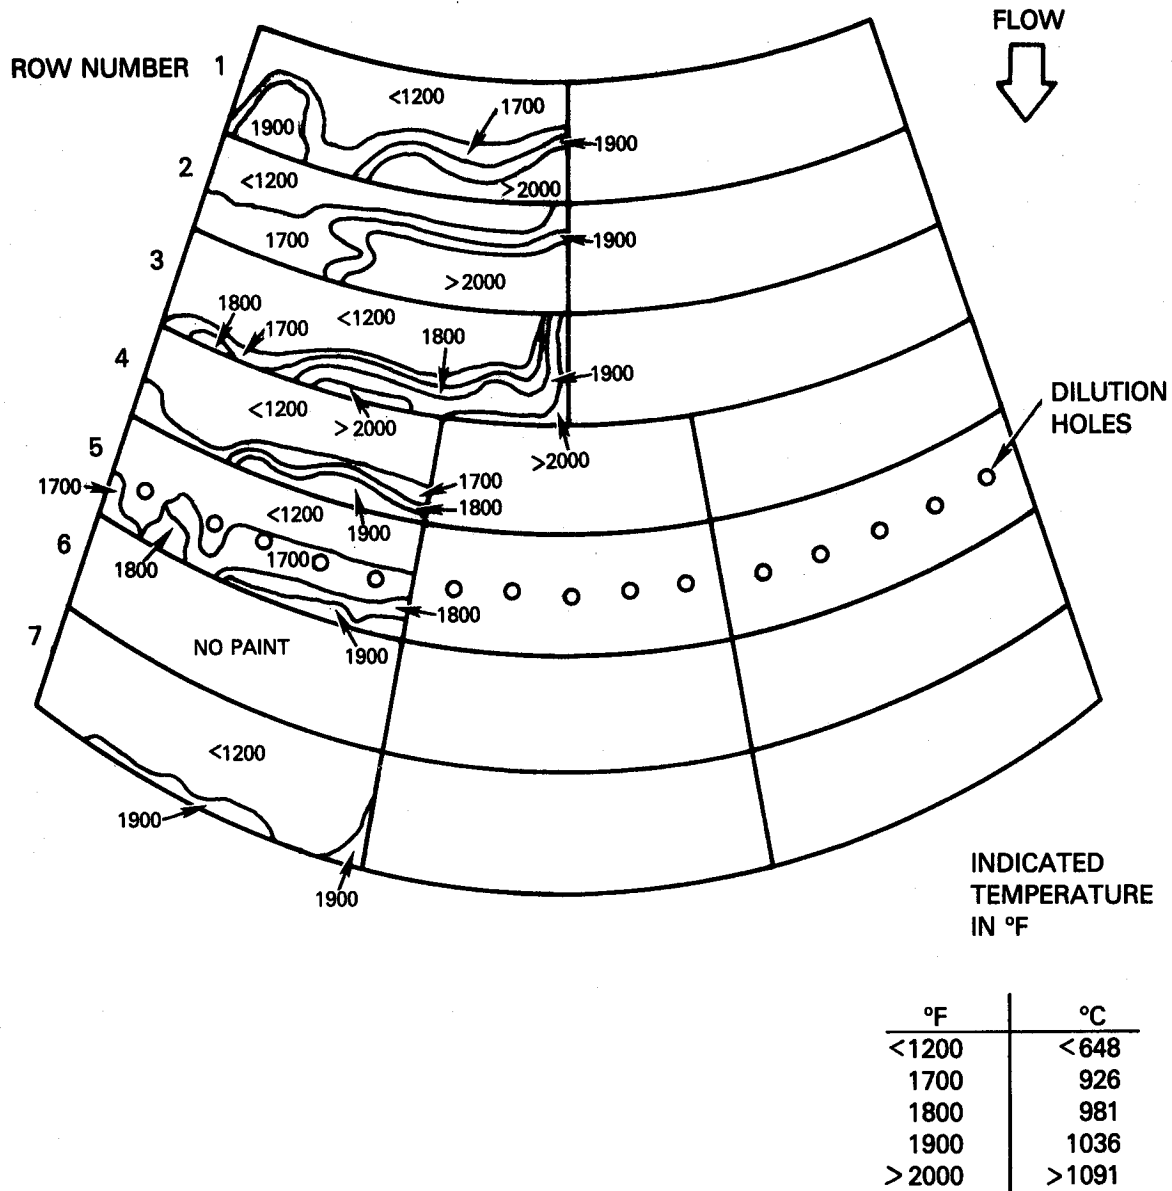
Figure 5-30 Ceramic Composite Liner Panel Hot Side Temperature Distribution

The Row 5 panels had dilution air jets penetrating through them and the presence of these jets led to higher hot surface temperatures across the entire width of the panel and not just behind or between the jets. Nonetheless, the surface temperature levels downstream of the dilution holes, at 926°C to 1036°C (1700°F to 1900°F) are moderate compared to predicted levels of Figure 3-27. It is of interest that the unpainted hot sides of the ceramic composite panels generally retained their original grey color during the test. The only exceptions appeared to be: 1) the presence of darker grey streaks, which are visible in Figure 4-10, between the dilution air holes on the Row 5 panels. These streaks persisted to a lesser extent onto the downstream Row 6 and 7 panels, and 2) an orange colored stain on the downstream surfaces of the Row 4 and 5 panels in the vicinity of the center to right panel juncture. Because of its singular appearance, the latter is thought to be caused by a carburetor tube on the outer liner producing a stronger than nominal jet penetration.

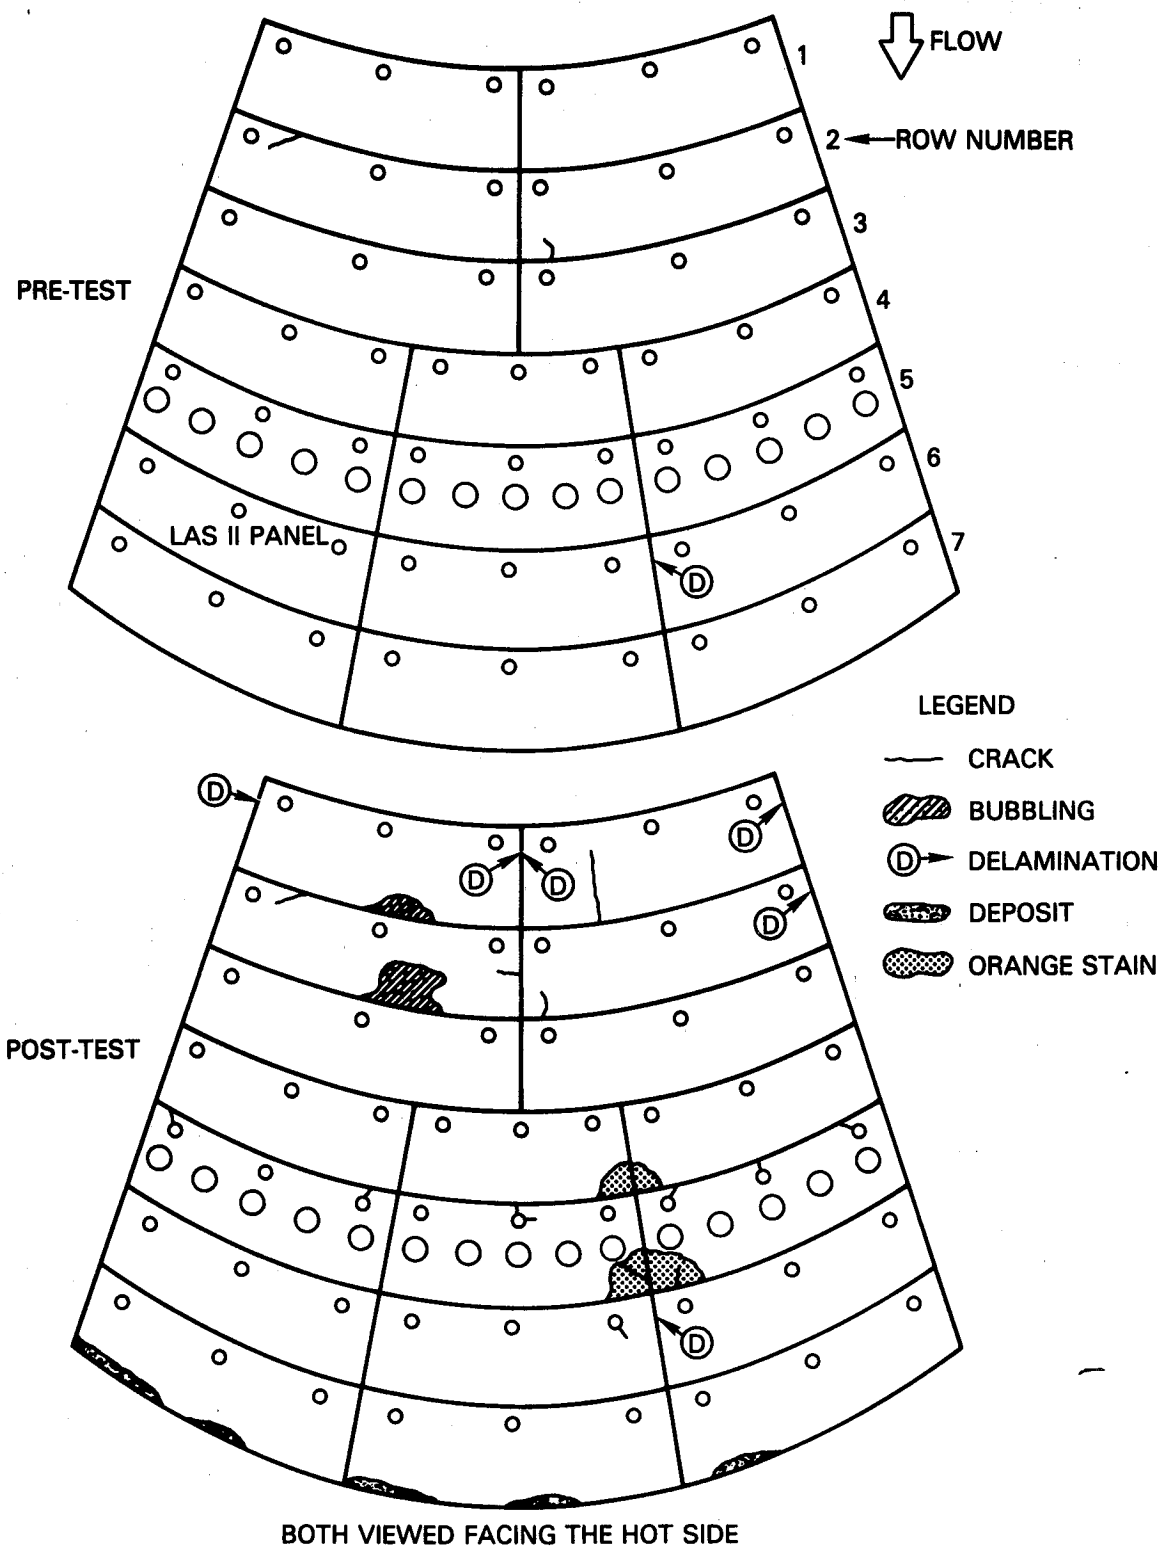
Figure 5-32 Condition of Composite Ceramic Liner Panels Before and After Combustor Rig Testing

As shown on Figure 5-32 the exposure in the sector combustor rig created four new cracks in the panels. Two of these, in the trailing edge of the right side panel of Row 1 and in the abutting edge of the left side panel of Row 2 were in the high temperature region produced by the pilot stage fuel injector on the rig centerline. The Row 2 crack in particular is in an area where the interpretation of the thermal paint had indicated hot gases may have gotten under the panel at the juncture. The other two new cracks occurred near the trailing edge of the Row 5 panels. There is no immediate reason for their occurring in this area but it is possible they could be associated with stresses induced by the machining of the dilution air holes in these panels. None of the new cracks were as severe as that present prior to test in Row 2 in that they did not penetrate the full thickness of the panel. All of these cracks started on the hot side surface and extended through 4, 4, 6, and 1 of the eight plies in the Row 1, Row 2, Row 5 center and Row 5 right panels respectively. Curiously the cracks in the Row 5 panels are in the region of orange staining that was previously considered as being caused by impingement of flow from a carburetor tube.

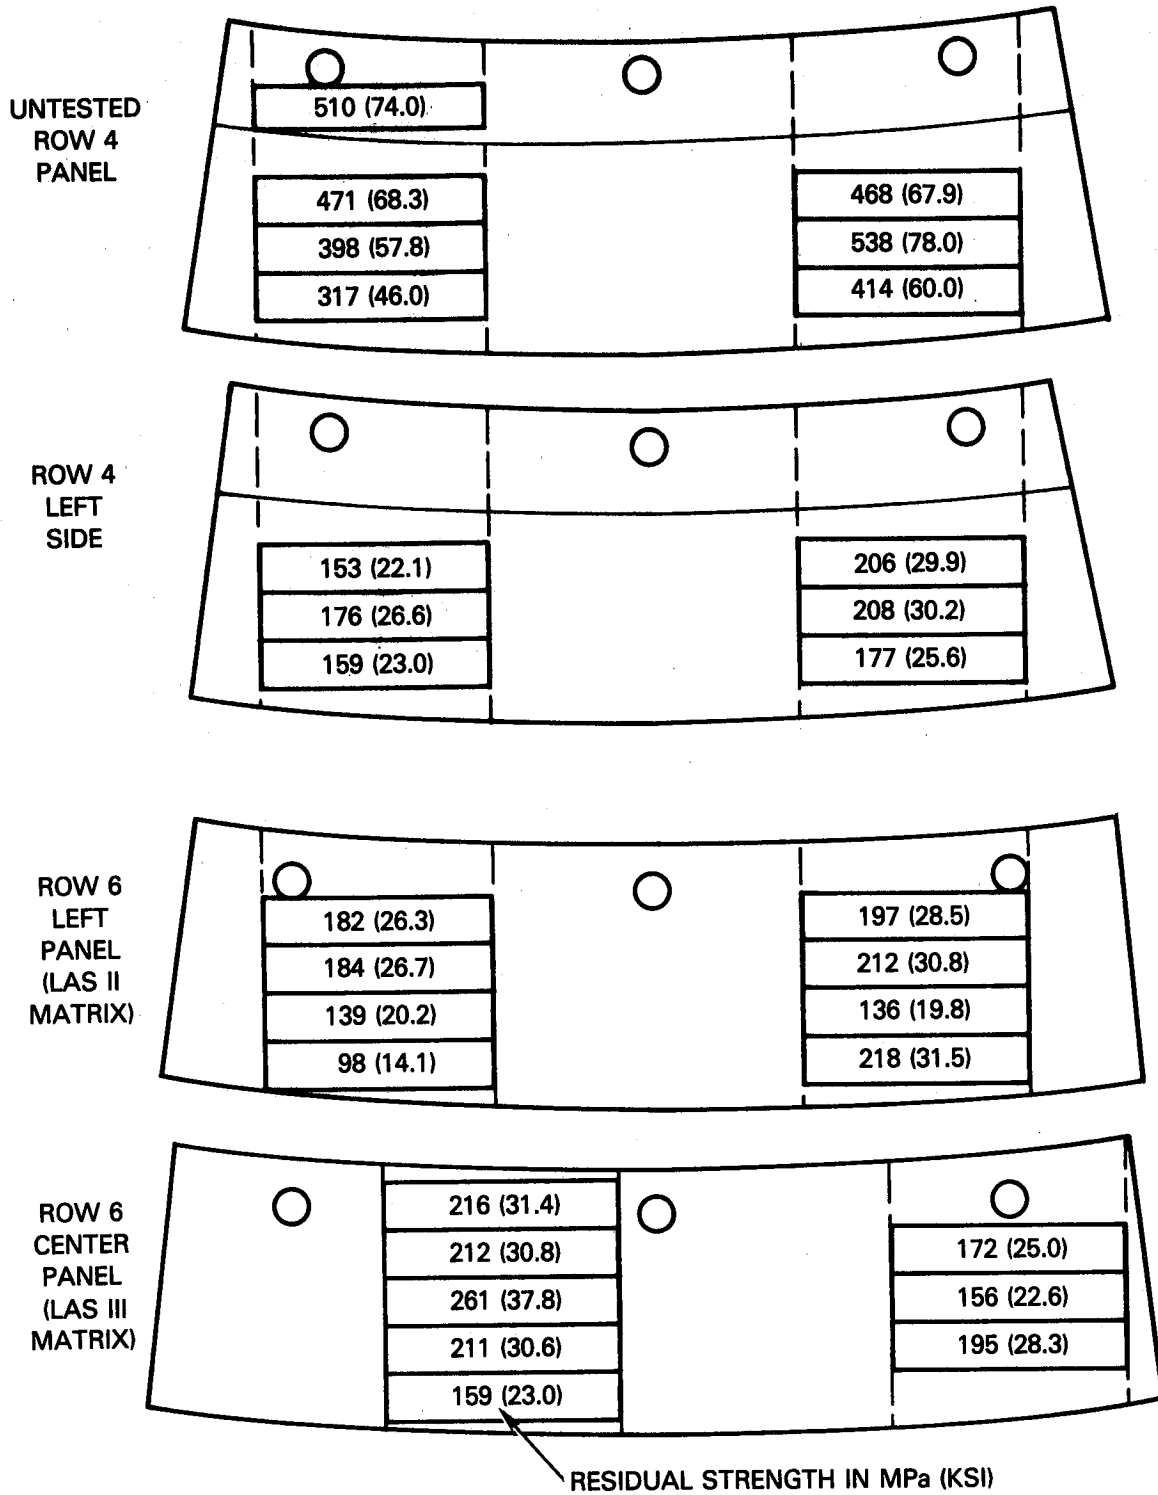
Figure 5-35 Residual Strength of Specimens from Ceramic Composite Liner Panels

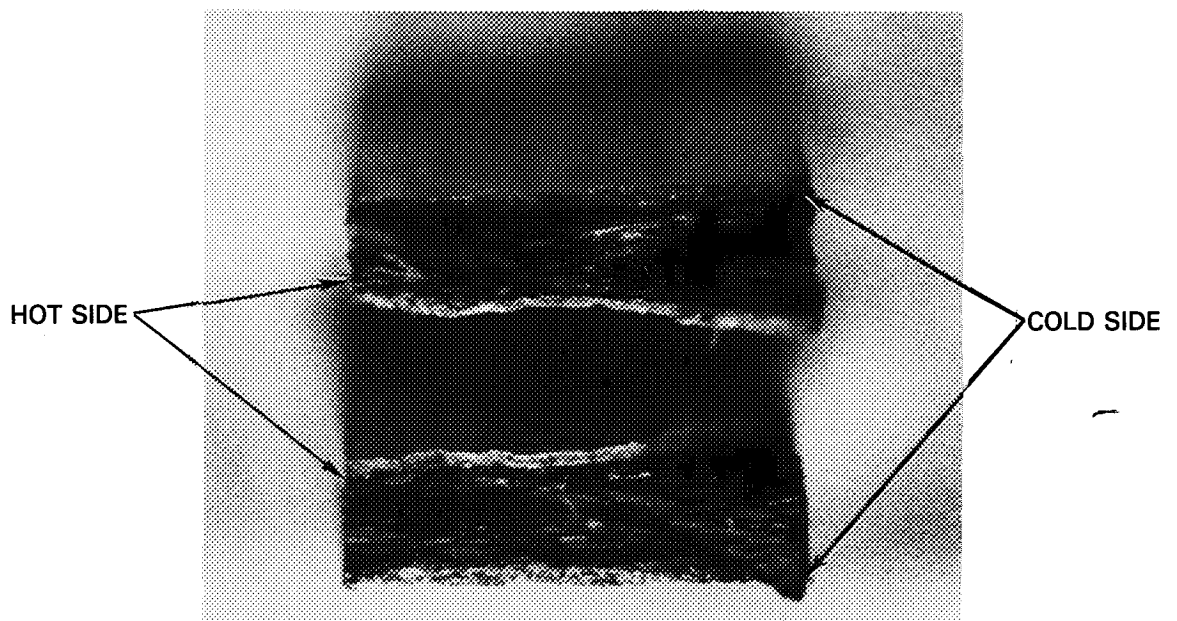
Figure 5-36 Fracture Morphology of Residual Strength Specimens from Ceramic Composite Liner Panels

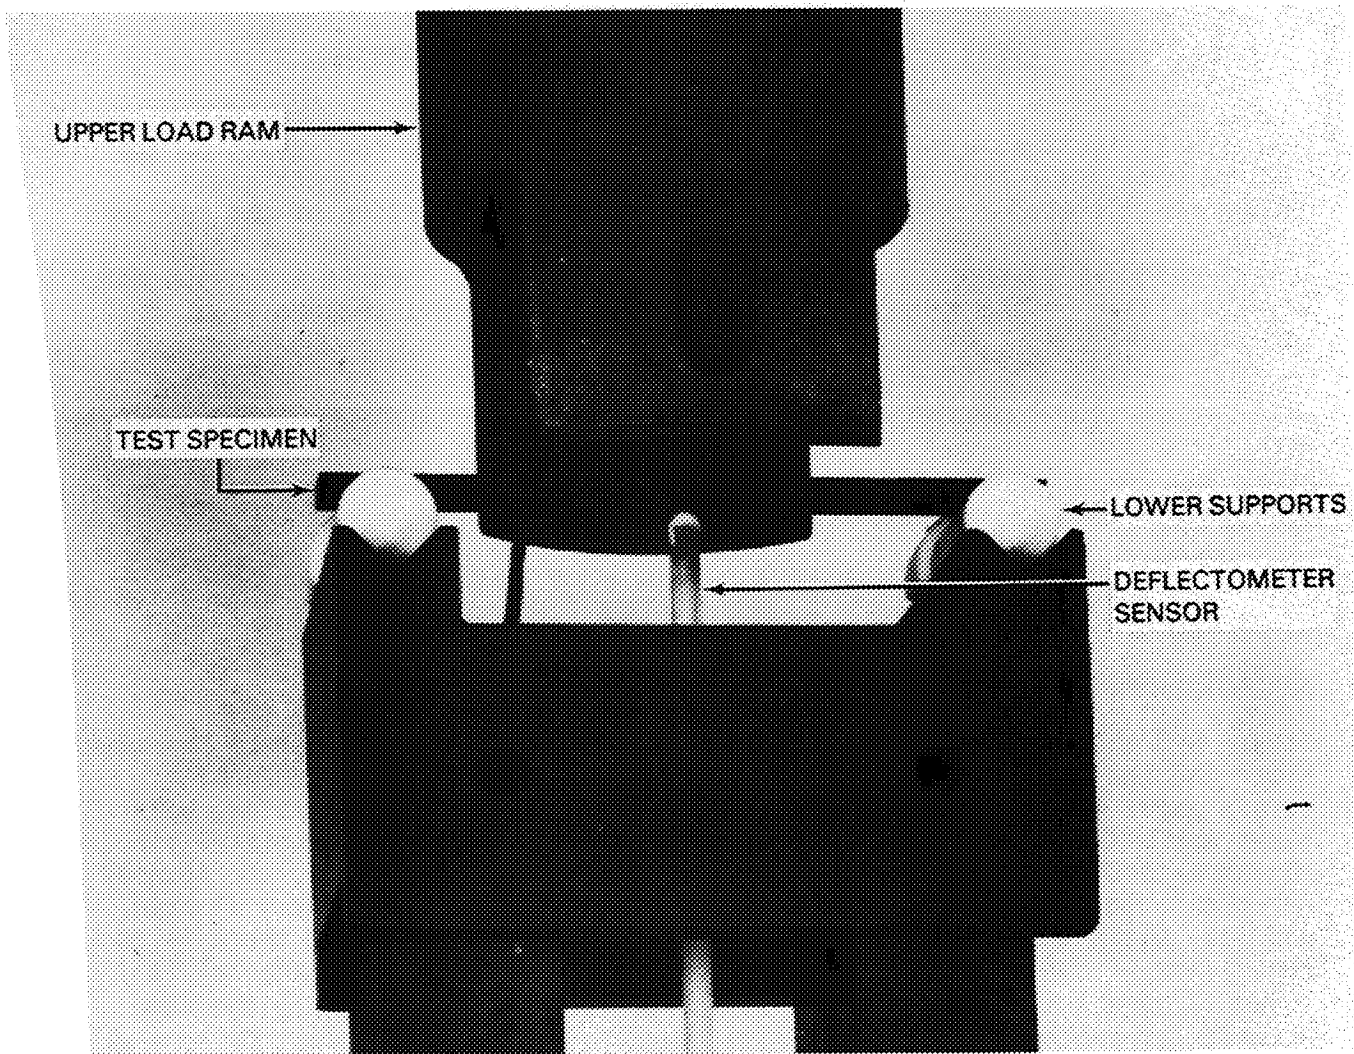
Figure B-1 High Temperature Flexural Test Facility

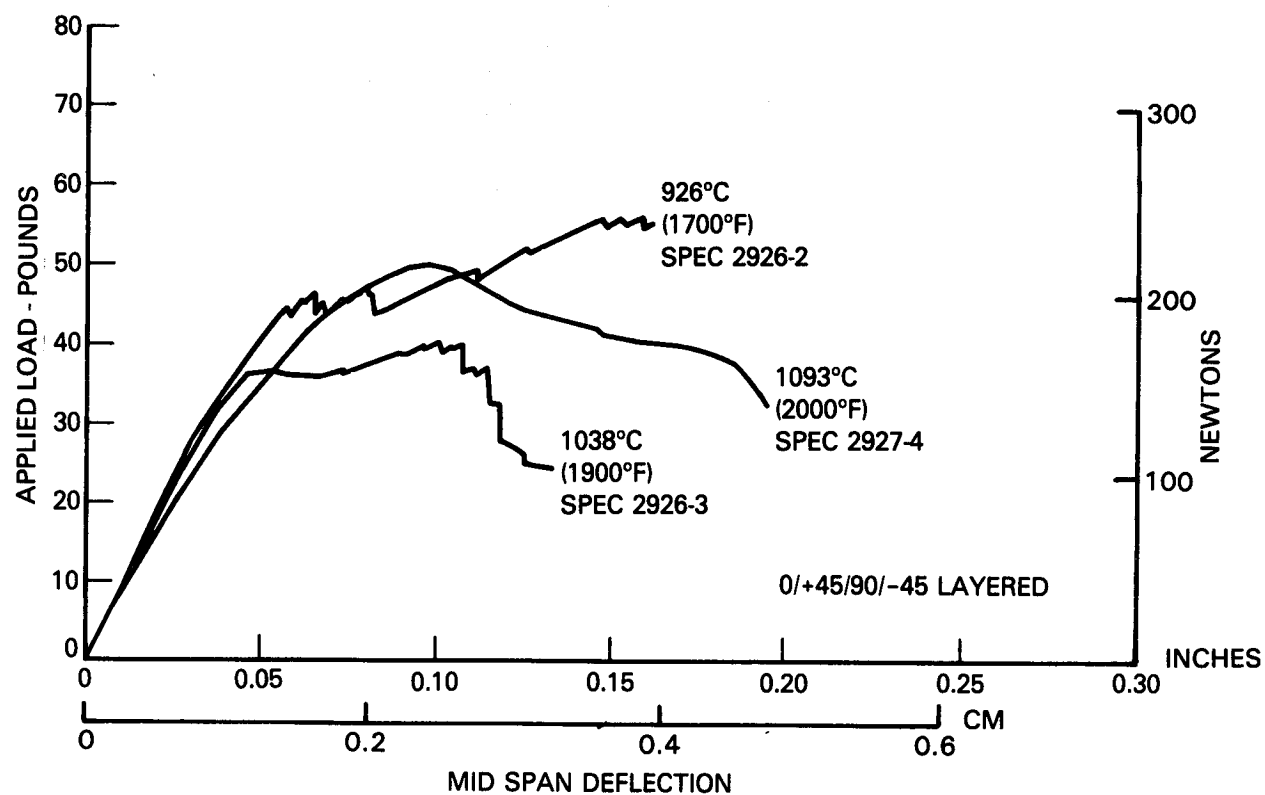
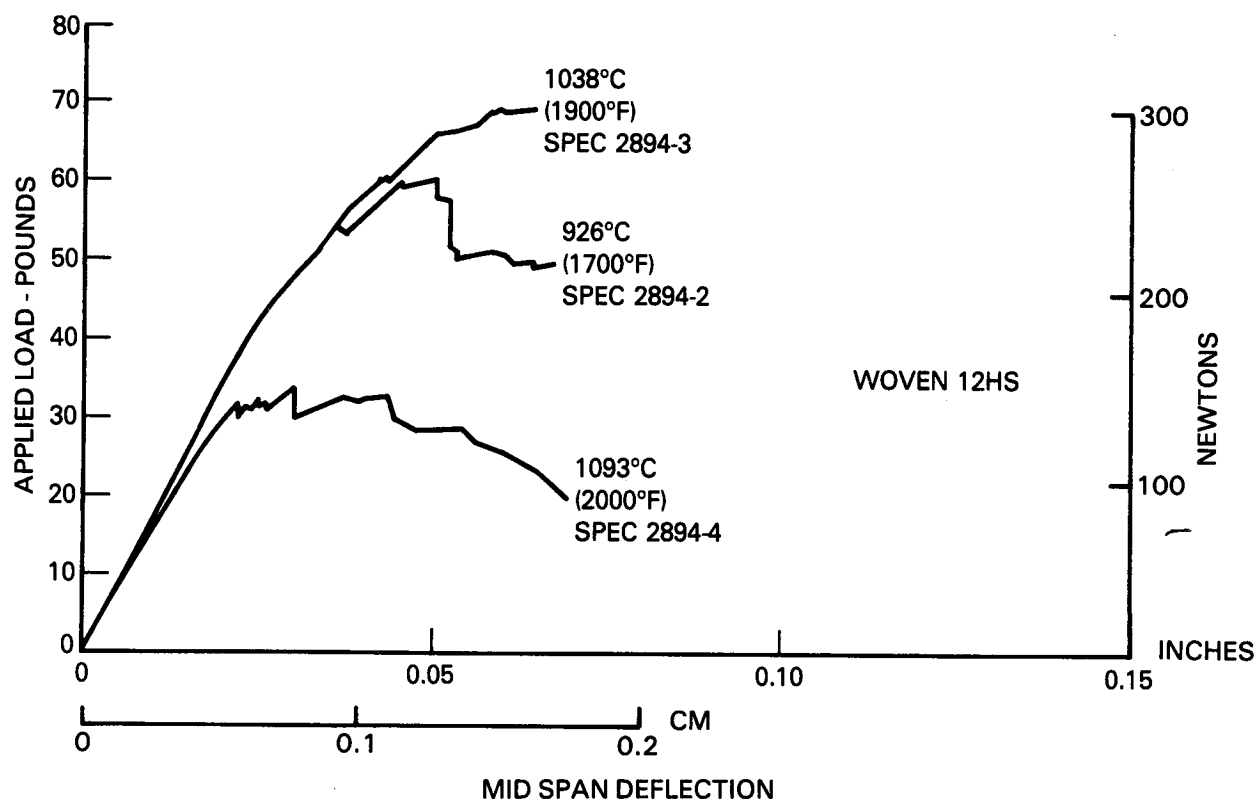
Figure B-5 Load-Deflection Characteristics of SiC-LAS III Composites at Elevated Temperatures

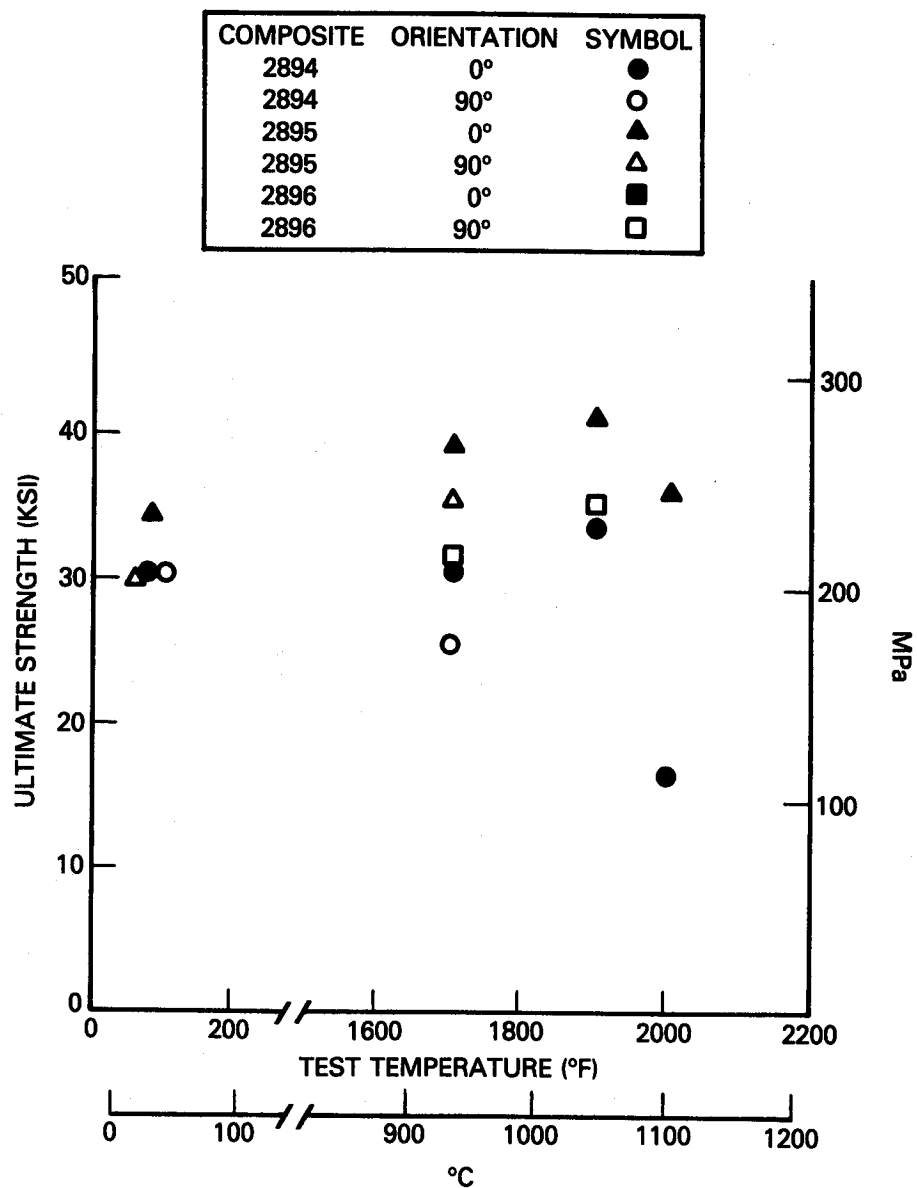
Figure B-6 Ultimate Strength of 12HS SiC-LAS III Composite in Air

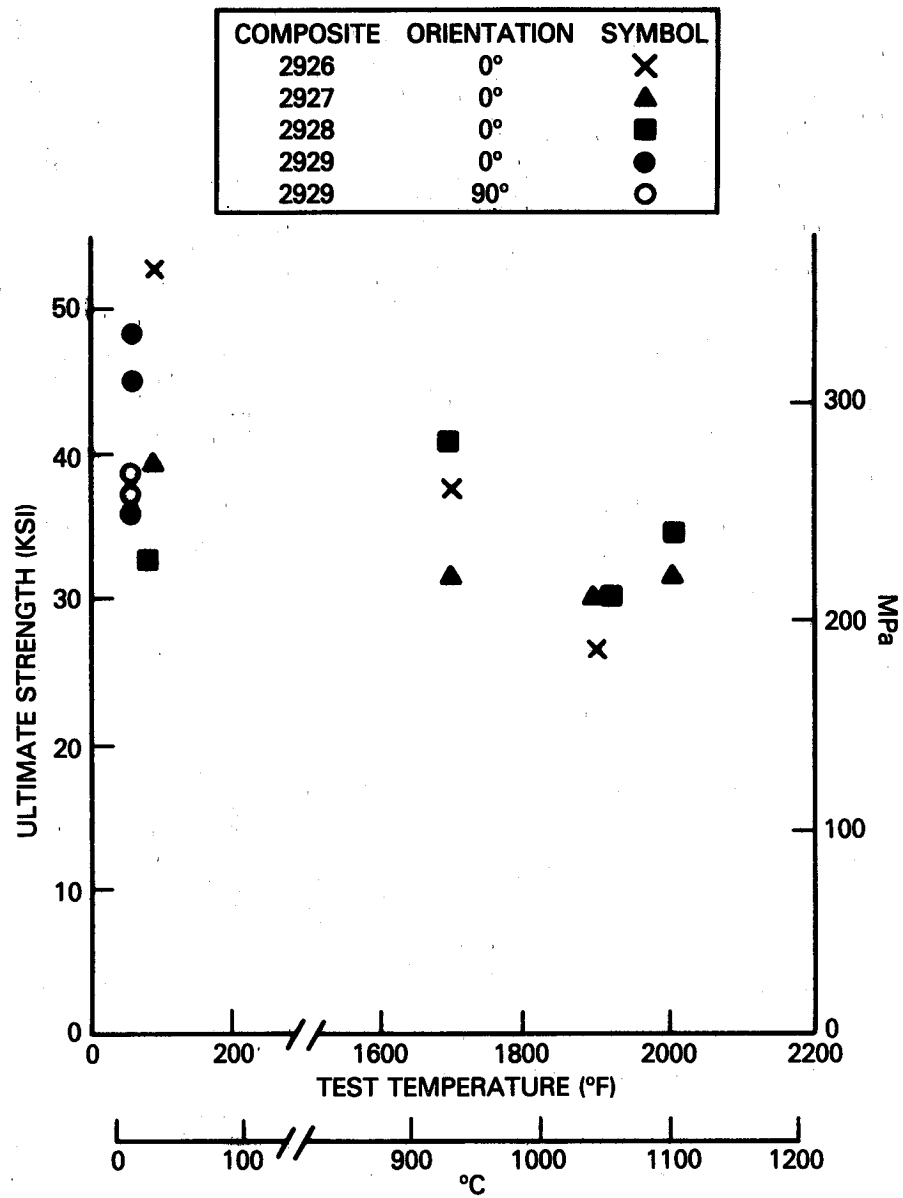
Figure B-7 Ultimate Strength of (0/+45/90/-45) SiC-LAS III Composite in Air

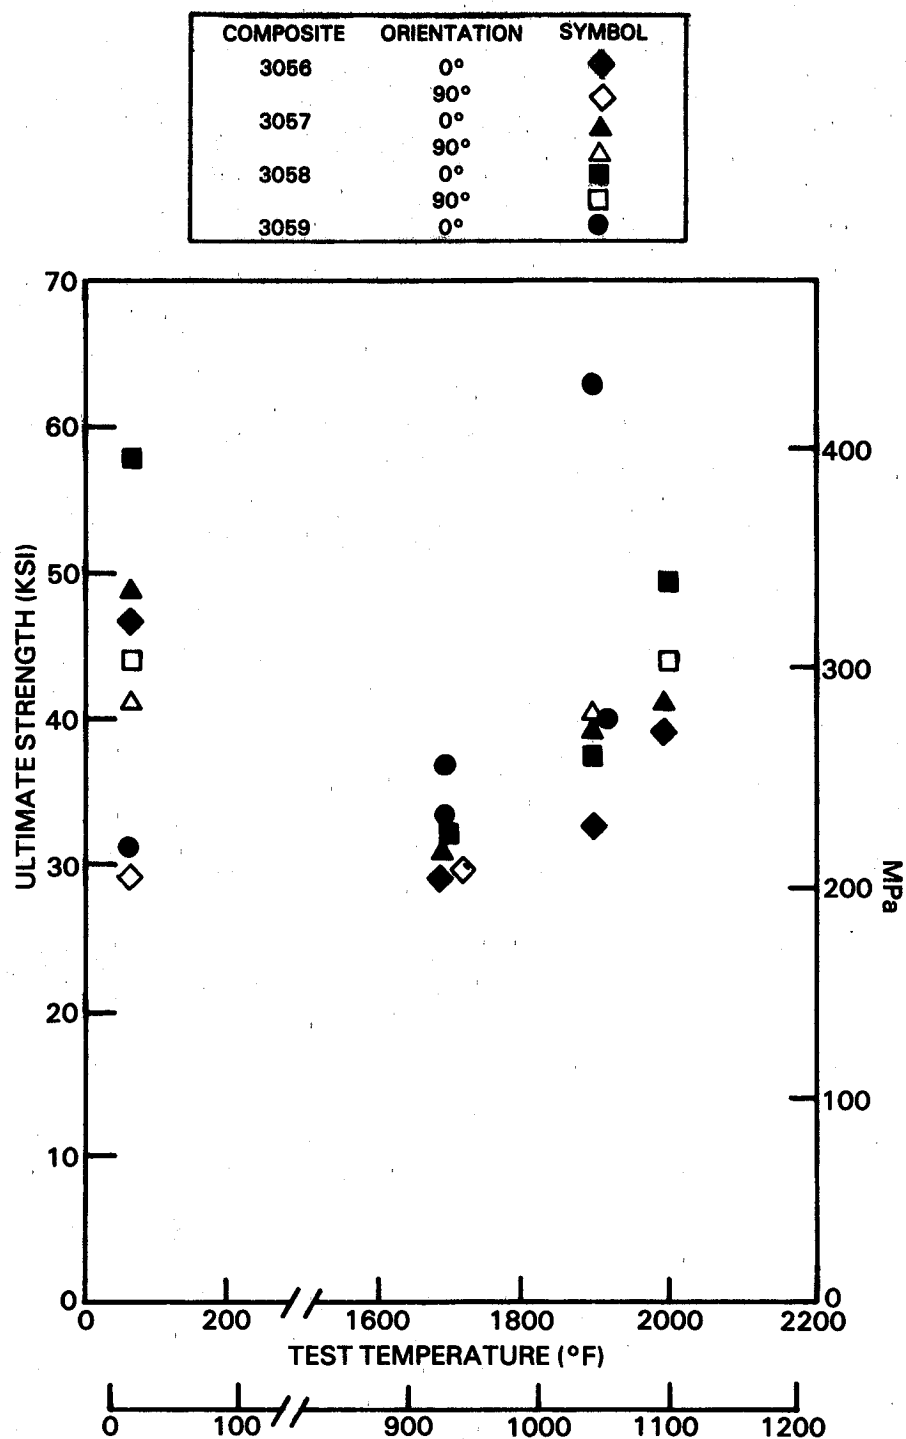
Figure B-8 Ultimate Strength of (0/+45/90/-45) SiC-LAS II Composite in Air

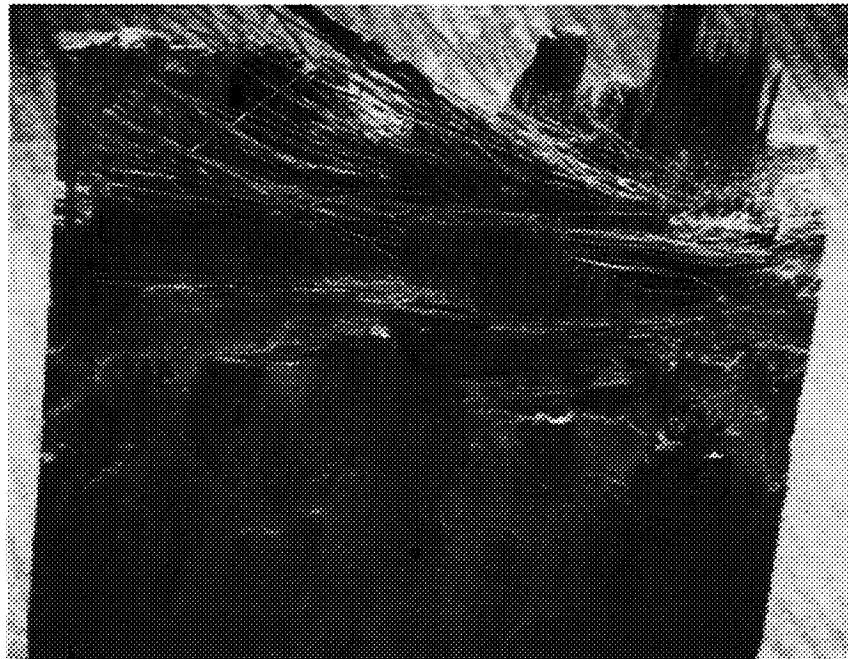
Figure B-10 Fracture Surface of 12 HS Woven Fiber Specimen After Static Failure Following 100,000 Fatigue Cycles at 1038°C (1900°F)

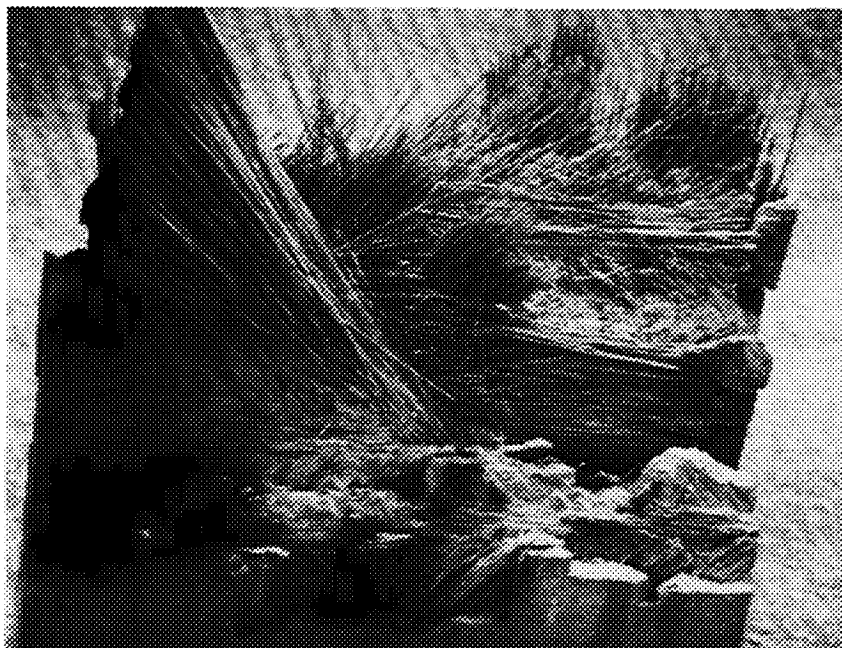
Figure B-11 Fracture Surface of 0/+45/90/-45 SiC-LAS III Specimen After Static Failure Following 100,000 Fatigue Cycles at 1038°C (1900°F)

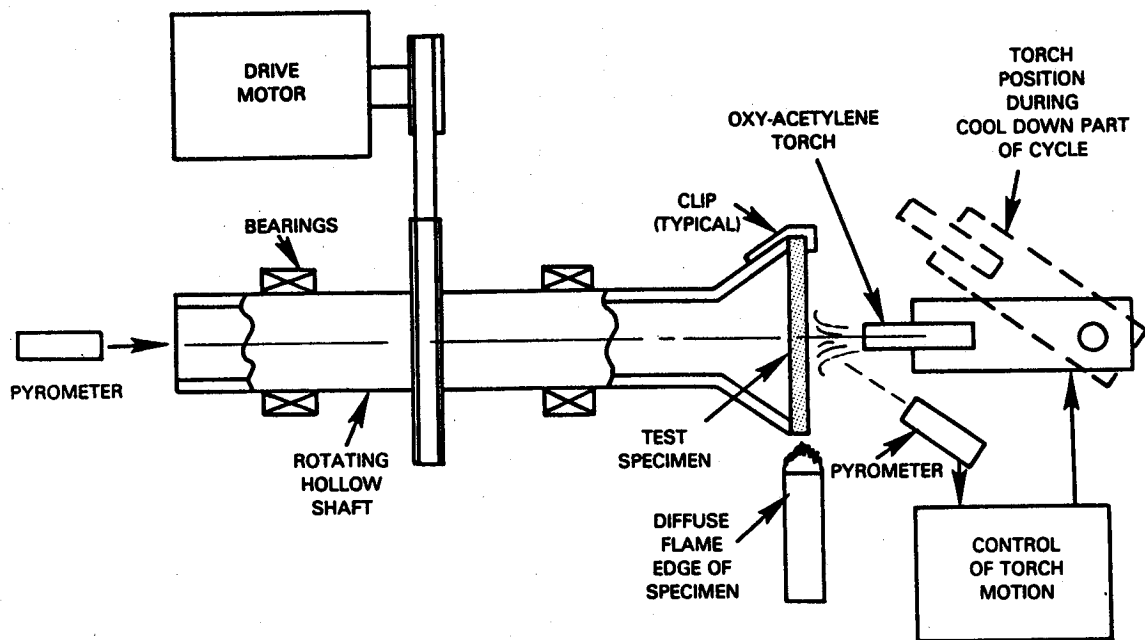
Figure B-14 Schematic View of Thermal Fatigue Test Apparatus

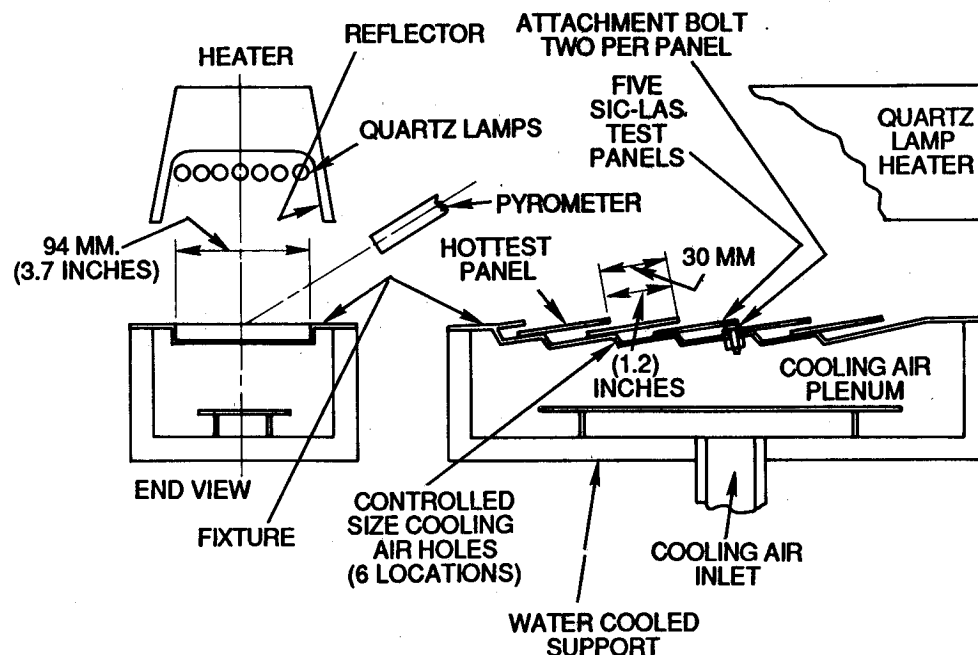
Figure B-17 Test Apparatus for Long Duration Thermal Exposure Tests
